The Rehabilitation of The Road Bridge Over The Nišava in Niš

Vladimir Radojičić ,Tomislav Radojičić

Abstract - The road reinforced concrete bridge over the Nišava in Niš is a continuous girder bridge 36+62+36 in span, total length 134 m. The total width of the pavement is 13 m out of which there are two traffic lanes, each is 6,5 m wide and two footways, each is 2 m wide and they are raised 30 cm from the pavement.

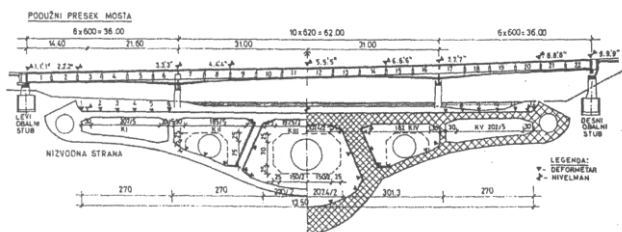
Fig.7 Placement of the instruments of measurement
