The Allergic and Irritating Reactions to Metallic Implants with Trauma – Orthopaedic Patients

Beata Swieczko-Zurek

The article presents the analysis of clinical operation complications after the treatment of long bones by mean of osteosynthesis with the use of metal implants and endoprothesoplastic of hip joints.

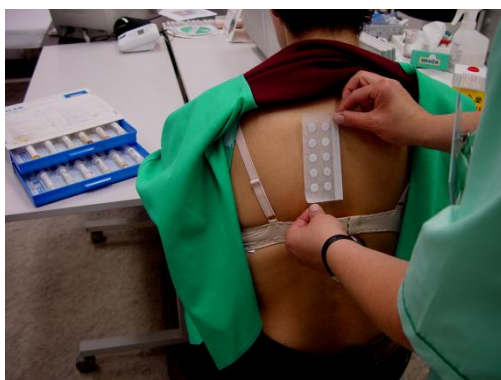
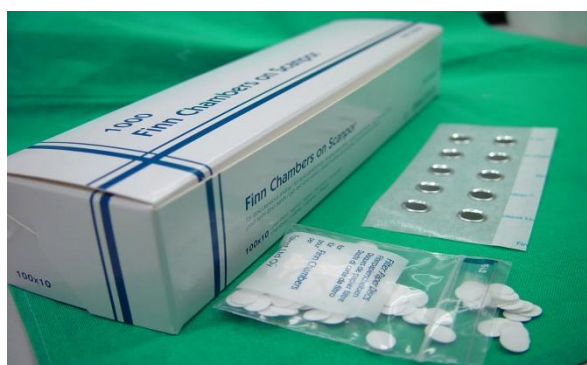
Fig.1 Skin tests [5,16]

The skin tests with choosen Ni, Cr and Co haptens were applied to patients as advised by JDCR (International Group Examining Contact Eczema) in shoulder blade vicinity. Stickers with opening covered with polypropylene were used. The results were examined after 48 h, 72 h and 96 h counting from application time (Fig.1).

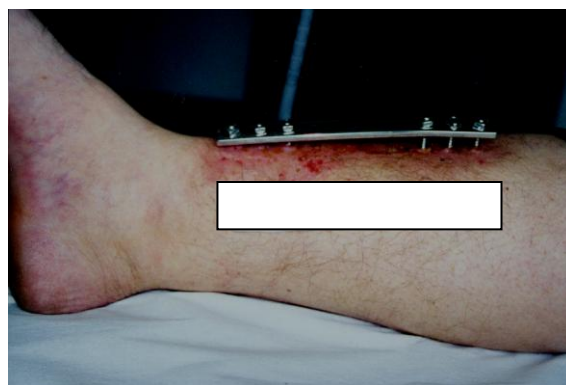
Fig.2 The gaskin fractions joint by means of *Zespol* method, X-Ray photo [16]

The first case is associated to the bone disturbances following the inserting of an implant with inflammation in the surrounding area and positive patch tests (Ni, Cr, Co) concerned gaskin fractions joint by means of *Zespol* method (Fig.2). For this case a segment of the body tissue was

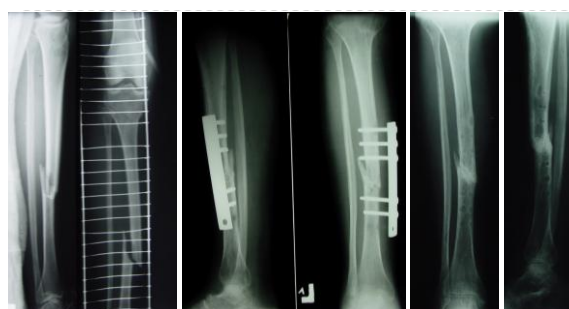
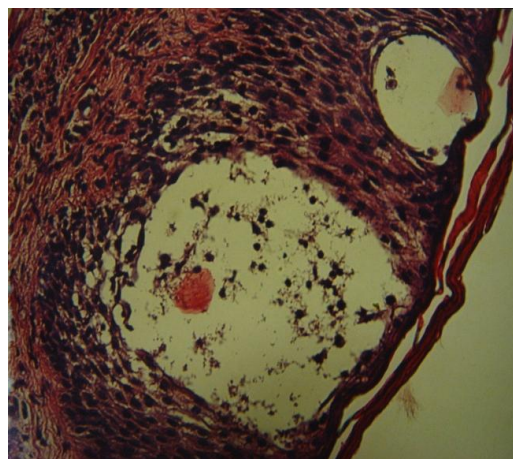
Fig.3 The segment of the body removed from the implant area by use of the *Zespol* method [5,16]

removed from the implant area (Fig.3). It revealed, that the tissues surrounding the implant died out and the implant lost balance. After removing the implant and drugs treatment, the tissues started to recover.

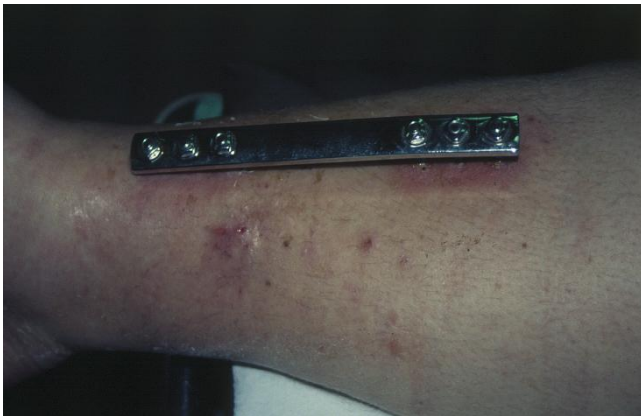
Fig.5 Contact rash [16]

Among many reasons causing complications, increasingly frequent phenomenon is oversensitiveness to metals contained in an implants used in stabilization of fractions (Fig.4). It has been found, that patients suffering from oversensitiveness experienced skin irritation in the area contacting implant (Fig.5). The observations indicated, that the contact rash was stronger, if an implant was inserted nearer the surface of the skin (Fig.6).

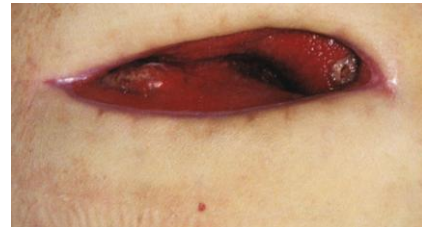
Fig.7 The allergic changes [5,16]

In most cases allergic changes resulted in the necessity of removing an implant and led to steady disability of the patient (Fig.7). The fig. shows an open wound with abscess after introducing hip implant (fig. in the middle). The fig. on the left presents an endoprosthesis introduced into human body, whereas the fig. on the right shows hip joint after the removal of the implant.

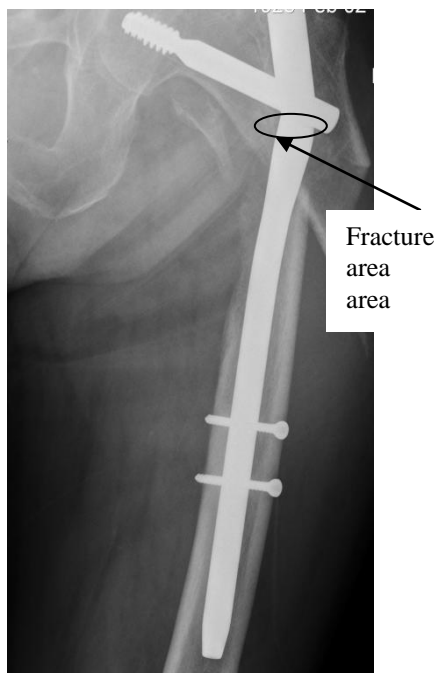
Fig.8 The picture of Gamma nail in the leg with fracture area [16]

The nail was mechanically examined. The microscope examination revealed some fraction in the material in the joint between the screw and the nail (Fig.8).

The examination of fixator breaking was restricted exactly to the area of breaking, which is shown in Fig.8.

The observations of the fixator (Gamma nail) fracture show that failure has fatigue nature with characteristic focus of the stresses concentration. The analysis of biomechanical loading of the nail (Fig.8) and the fracture (Fig.10) indicates that concentration of variable stresses most probably appeared of the hole edge in the Gamma nail. It can't be excluded, that the course of fatigue fracture might have been started by micro fracture caused by the impact of loading (for example a fall) and its further advancement in the course of further use of the examined Gamma nail.

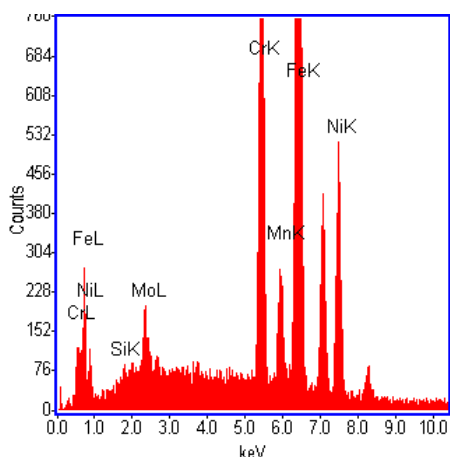
Fig. 9. The spectrum and the chemical composition of the Gamma nail material

The analysis of Gamma nail fracture started with macroscopic observation of the outer surface as well as the whole surface in the fracture area. No signs of mechanical or corrosion destruction were observed on the outer surfaces. While some dishes in the whole surface were spotted in the fracture area. It was plastic deformation of the nail in the contact place with the screw. The chemical composition of the Gamma nail material was examined by means of the Scanning Electron Microscope Philips XL 30, equipped with devices to analyse the chemical composition (EDS), and the results were presented as a spectrum and the print in Fig.9.

Element	Wt %	At %
SiK	0.58	1.16
CrK	17.57	19.09
MnK	1.93	1.99
FeK	59.97	60.68
NiK	14.29	13.75
MoK	5.66	3.34
Total	100.00	100.00

Element	Net Inte.	Bkgd Inte.	Inte. Error	P/B
SiK	2.34	4.71	14.66	0.50
CrK	151.88	6.61	0.85	22.98
MnK	13.25	5.77	3.76	2.30
FeK	358.53	5.32	0.54	67.39
NiK	58.28	4.06	1.40	14.35
MoK	2.07	1.38	10.62	1.50

The chemical composition analysis proves that, the material of the examined nail is stainless Cr-Ni-Mo steel. According to the Schaeffler’s diagram, the austenitic structure of the examined material was found. Its hardness was defined by means of Vickers method of measurement by loading of 294,2 N. The average hardness of the Gamma nail is presented in Table 1.

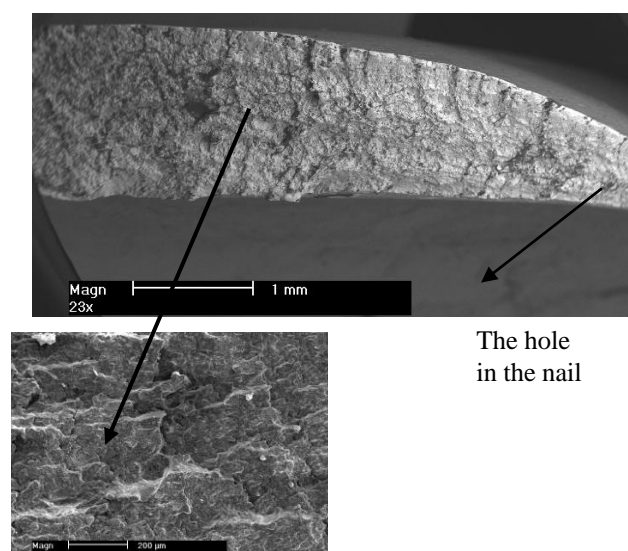
Fig.10. View of the fatigue fracture of the Gamma nail

The observations of the fatigue fracture were performed using the SEM with different magnifications (from 23x to 1000x). The chosen views of the fatigue fractures are presented in Fig.10.
